RE: RePlay - Agricultural Oil Seal & Preservation Agent

RePlay® Agricultural Oil Seal and Preservation Agent

**Location: Victoria Avenue from Elphinstone Street to Angus Street (Eastbound)
Fleet Street from 7th Avenue to Hall Street (North and Southbound)**

OMAHA, NEBRASKA Replay Road Test

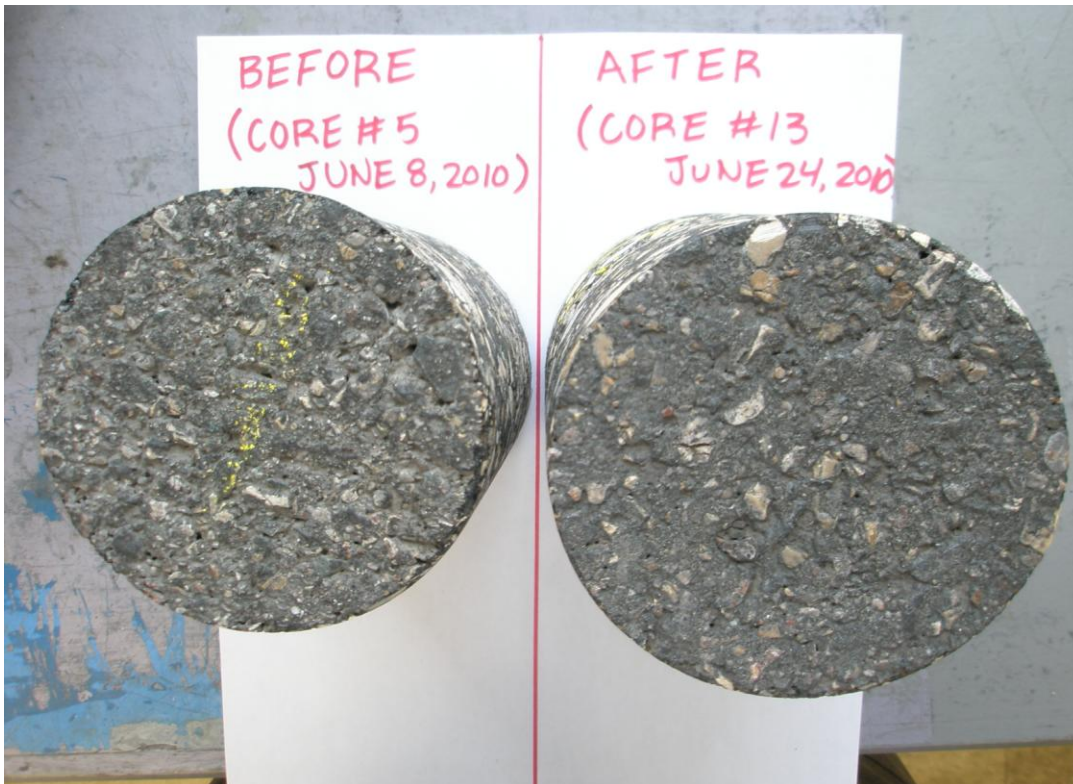
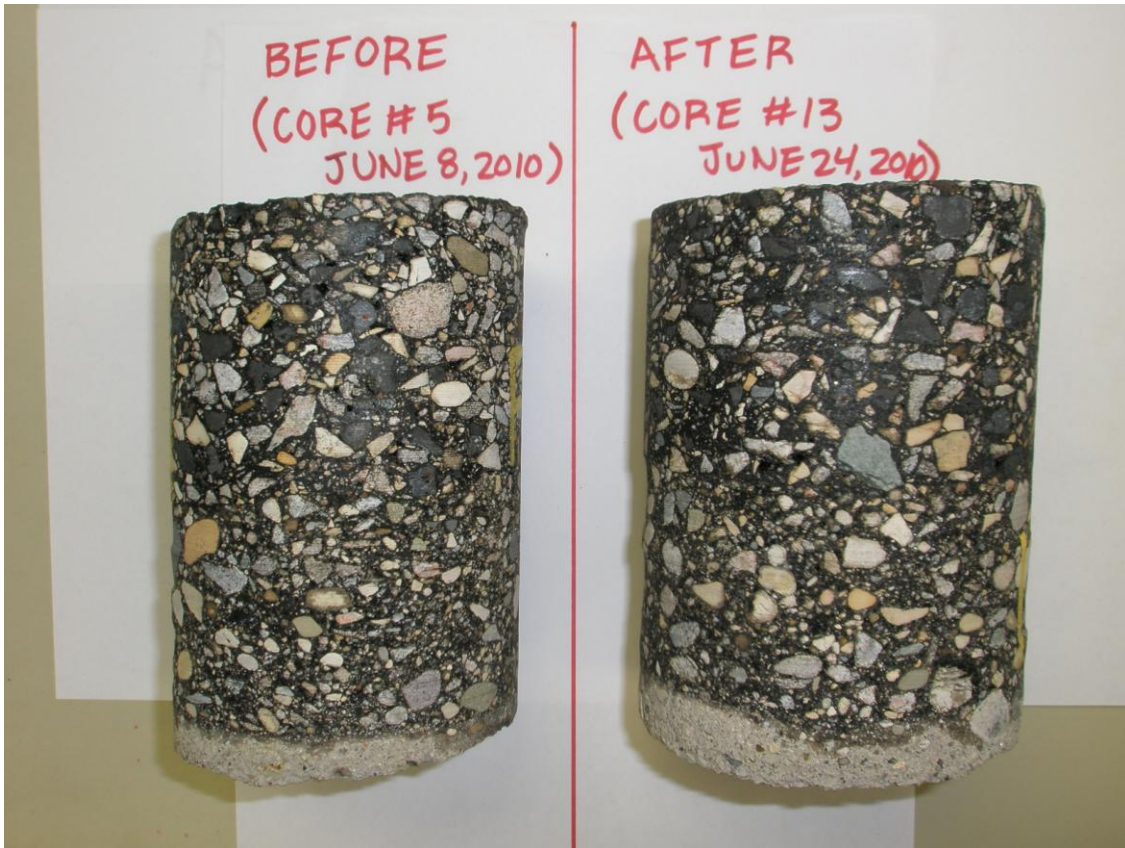
The cores obtained from Victoria Avenue and Fleet Street indicated a high amount of voids and were poorly consolidated. After the RePlay® application the surfaces of the cores voids were closed, and any of the voids that extended below the surface were closed. The penetration of the RePlay® product for Victoria Avenue was not detectable to be measured; however the pictures of the sides of the cores compared before and after the application seem to show the voids to be significantly reduced.

Example pictures of cores taken at #1243 Fleet Street, Northbound lane, 5.5 m West of the curb.

It appears that the penetration of the product has closed the surface significantly, and should provide a barrier to air, water and de-icing salt penetration to the voids within the pavement layer. Monitoring of these section as well as future testing will determine the long term performance of the RePlay® product.

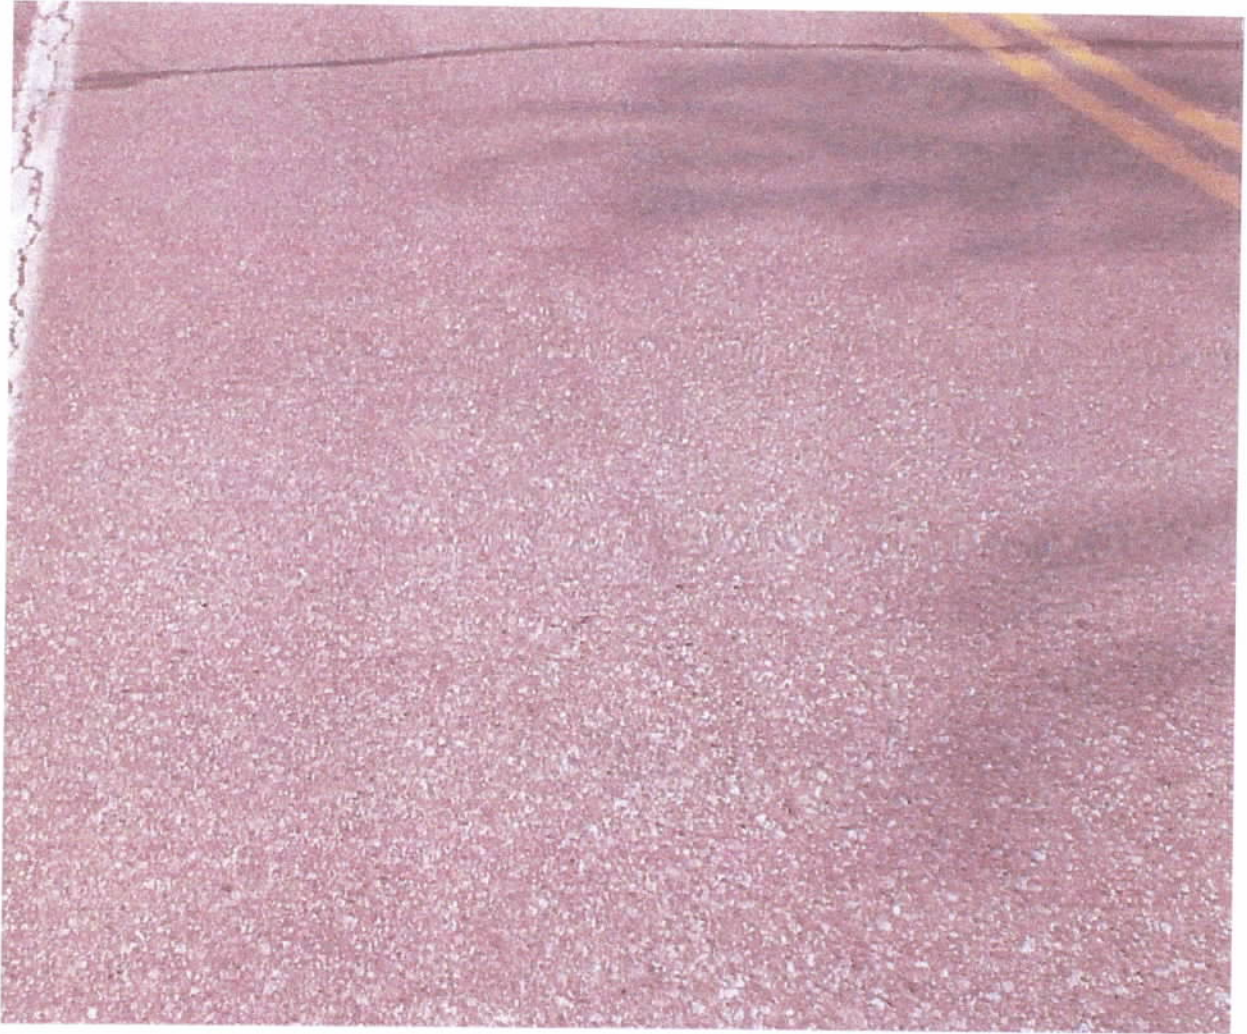
After our application, we saw penetration from 1" to 1 3/4" down in the cracks the next day, even though we had a slight wind drift problem at the time of application. We'll be interested in what the results show 4 years later.

After several years of treatment, I am pleased to announce that the cracks in the roads we treated with REPLAY have not reopened and the edges are still intact. We also noticed that there hasn't been any decrease in nighttime visibility of our lane striping. The overall appearance of the treated roads is better than the non-treated ones and there seems to be an improvement in skid resistance.
